January 2, 2003

Site Inspection, Jon Young, Torrey Buff Quarry, S/055/012, Wayne County, Utah

ATTACHMENT Report Date January 2, 2003; Inspection Date December 13, 2002 Photographs S/055/012, Torrey Buff Quarry, Jon Young

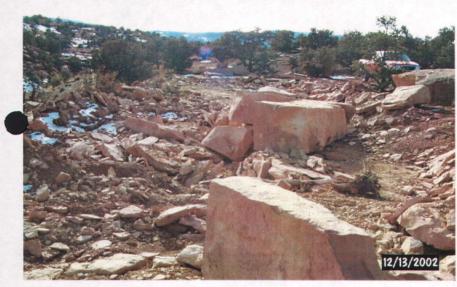
The quarry is about 200 feet long and 50 feet wide and, as I recall, about three feet deep (Photo 1). Some of the apparent waste material has been pushed east, away from the operation area (Photo 2). The operator has been taking a reddish tan sandstone. There were about 7-8 pallets on site but no palletized stone. Some of the stone shows signs of being split.

Photo 1. View looking approximately south.

The operator needs to begin salvaging soil from any areas into which he expands. The operator also needs to pay the permit fee for 2002. The final notice was sent October 22, 2002, and this was to be turned over to the State Office of Debt Collection on November 29, 2002. The Division has the option of suspending the permit if the fee is not paid.

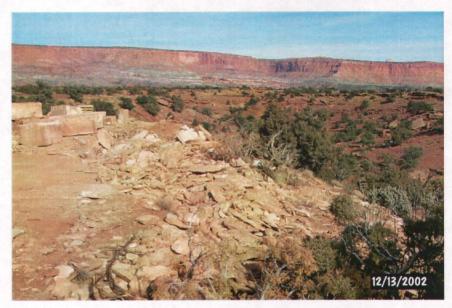
Photo 2. Material sidecast to the east of the quarry.
